Manhole Inspection Summary

Manhole # S35KK_048MH

Insp Date: **3/8/07 3:35 PM**

Location Address: **301 NORTH AVE**

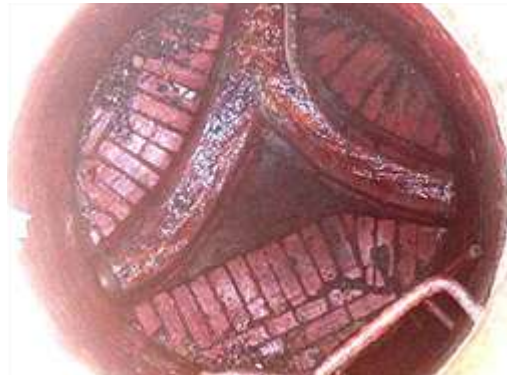
Top View

Count: **5** Missing: **0** ☒ **Corroded**

Corroded steps.

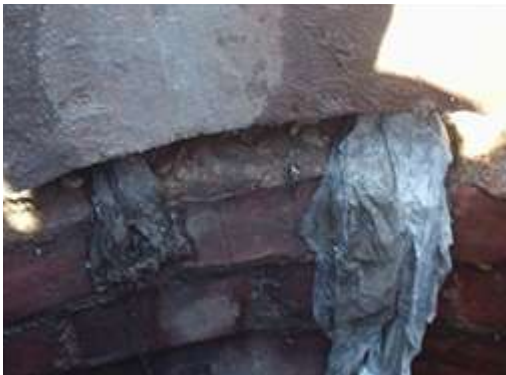
Defect

☒ **Leaks**

Condition: ☐ Sound ☐ Cracked ☐ Root Intrusion ☐ Loose Brick ☒ **Deteriorated**

Infiltration: ☐ None ☒ **Joint** ☐ Cracks ☒ **Mortar** ☐ Roots ☐ Wall

Frame leaks. Adjustment deterioration and infiltration.

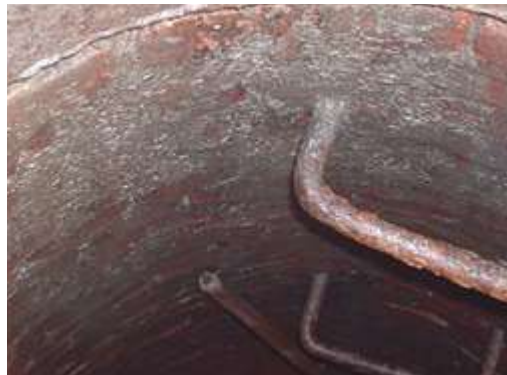
Defect

Adjustment infiltration - other side.

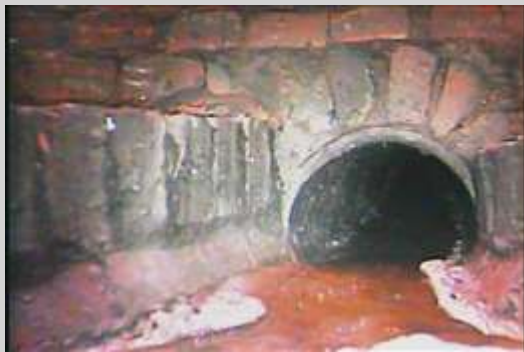
8 in. Circular Gravity Sewer Pipe Out @ 12 O'Clock

Deposits: ☐ None ☐ Mud ☐ Sludge ☐ Debris ☒ Grease

Silt Depth: **0** (in.) Deposits Extent: **Light**

Infiltration: **Evidence** Pipe Seal Cond: **Unknown**

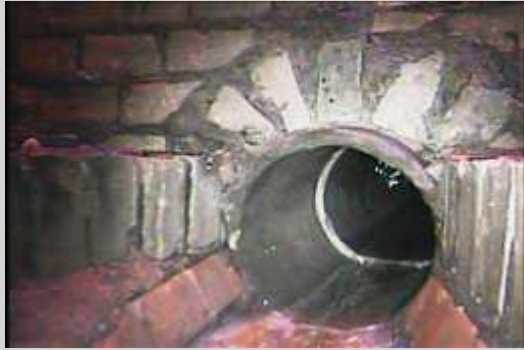
Pipe In @ 8 O'Clock

Condition: ☐ Sound ☐ Cracked ☐ Root Intrusion ☒ **Deteriorated** ☐ Leaks ☐ Debris

Channel deterioration.
